Geological Investigation for Environmental Impact Assessment (EIA): Case Studies from Some of Mini Hydropower Projects in Sri Lanka

Nanda Wipula Bandara Balasooriya

Faculty of Applied Sciences, South Eastern University of Sri Lanka,
Sammanthurai (E.P), Sri Lanka
E mail address: balasooriya@seu.ac.lk

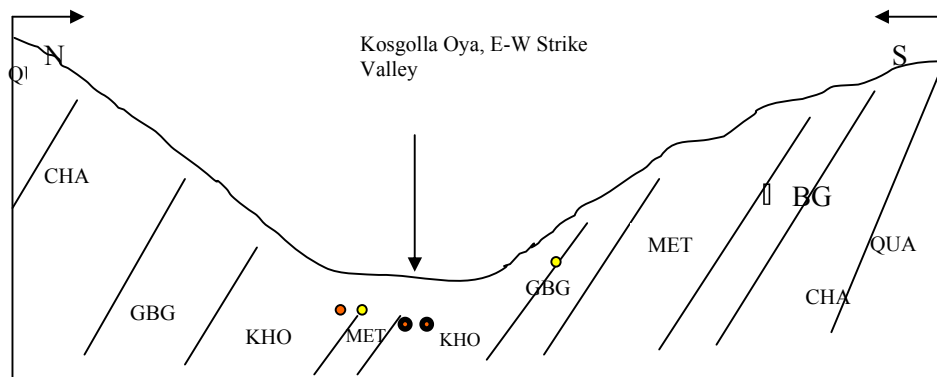
Fig.1: General Geology of Gammaduwa M.H.P. area

Length of Section , 1.5 km (approx.)
along the weir location (A-B)

Garnet, biotite gneiss (+/- Hornblende) is the major rock type, striking along NE-SW direction and dipping southerly about 50°-70°. Quartz (40%), Feldspar (25%), Biotite mica (20%), Garnet (10%), and +/- Hornblende 5-8%, are the major mineral composition of these gneissic rocks.
